## Aerosonde Mission Report:

# NASA Tropical Cloud Systems and Processes (TCSP) Experiment Costa Rica, July 2005

Report Prepared by:  
B. Mulac, Mission Scientist  
Aerosonde North America

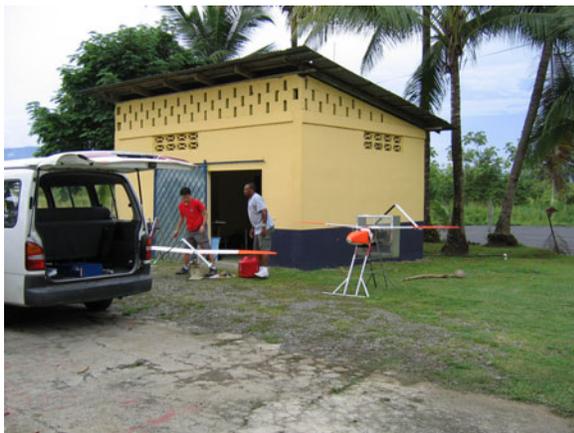
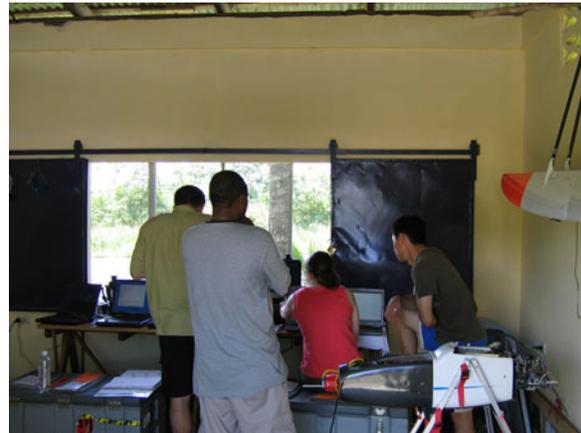
Figure 3. The Aerosome workshop, located at La Managua Airport.

A building next to the La Managua airstrip was used as the workshop for the operation (Figure 3). The building provided a secure space for maintenance and preflight procedures, and had running water, a bathroom, and power.

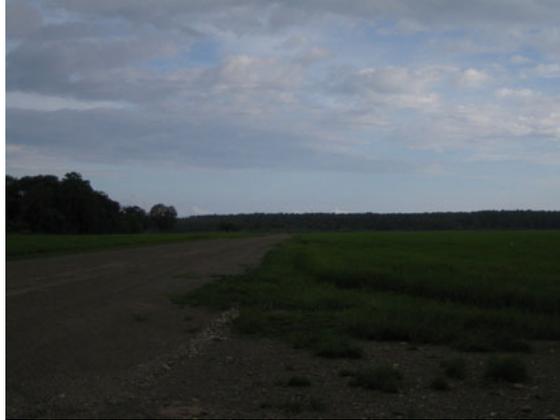
Figure 4. La Ligia airstrip

The La Ligia airstrip was identified and chosen as the new location for the launch and recovery site (Figure 4). Located near Parrita, approximately 25km north of Quepos, the dirt airstrip is privately owned and surrounded by rice fields. Air traffic consisted of a crop duster based at the airstrip. Antennas for long range UHF communications were set up at the field.

Initially, the launch and recovery site was to be the La Managua Airport in Quepos. However, upon arrival, it became apparent that the airfield was much busier than originally thought. Commercial traffic was frequent and a large number of charter aircraft flew in and out of the airport. It was determined that the airfield was unsuitable for operations and a search for a new location was undertaken.

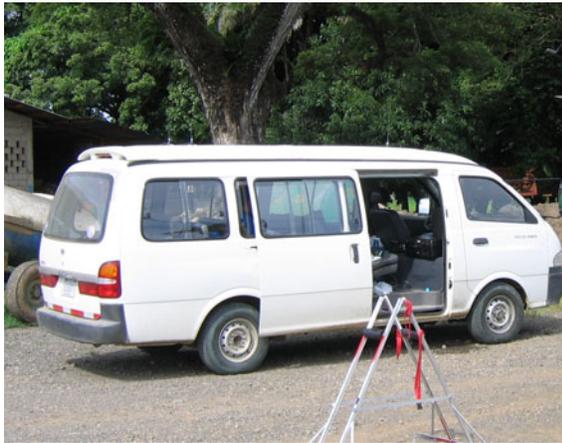
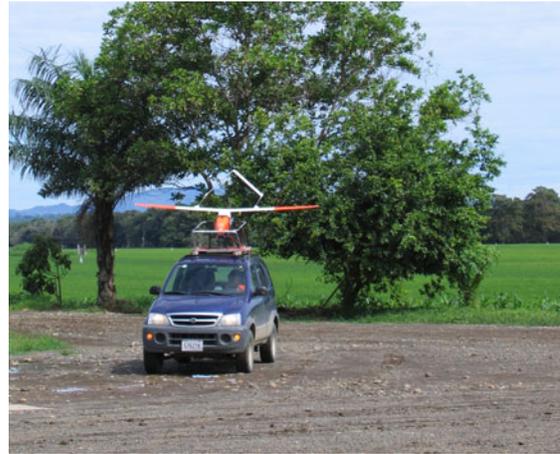
Figure 5. Ground command center and launch vehicle

Nick Logan, Ryan Vu, David Smith, and Jason Roadman made up the launch and recovery team. The ground command center was housed in a 15-passenger van and a small 4-wheel drive vehicle was used as the launch vehicle.
